PHYSICAL NEEDS ASSESSMENT

COUNTRY CLUB CREEK APARTMENTS 4501 E. RIVERSIDE DRIVE AUSTIN, TX 78741

PE Project No. 15.2356.01
January 6, 2016

***Physical Needs Assessment
Country Club Creek Apartments
4501 E. Riverside Drive
Austin, TX 78741
PE Project Number 15.2356.01***

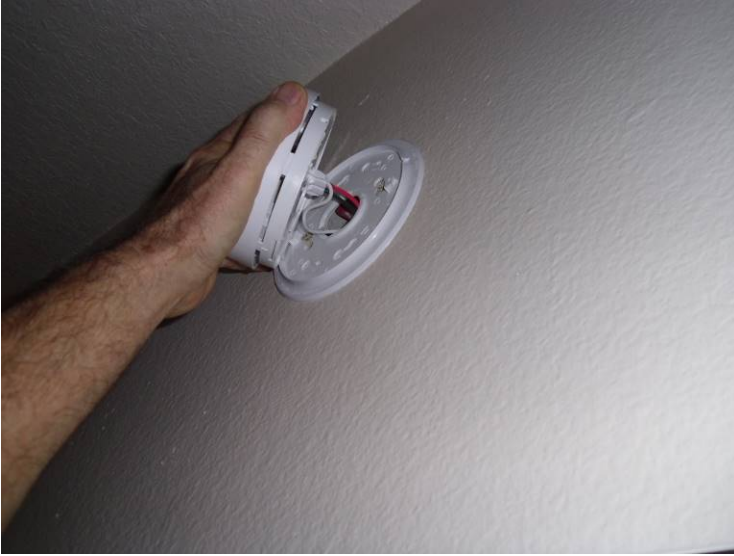
Fire notification inside the apartment units is provided with ceiling mounted, hard-wired smoke detectors with battery backup in the living room and bedrooms. The smoke detectors in several apartments were tested and found to operated properly. Replacements are completed when necessary by the site staff using the routine maintenance budget.

- 28. The apartment living rooms and bedrooms are provided with hard-wired smoke alarms with battery backup.

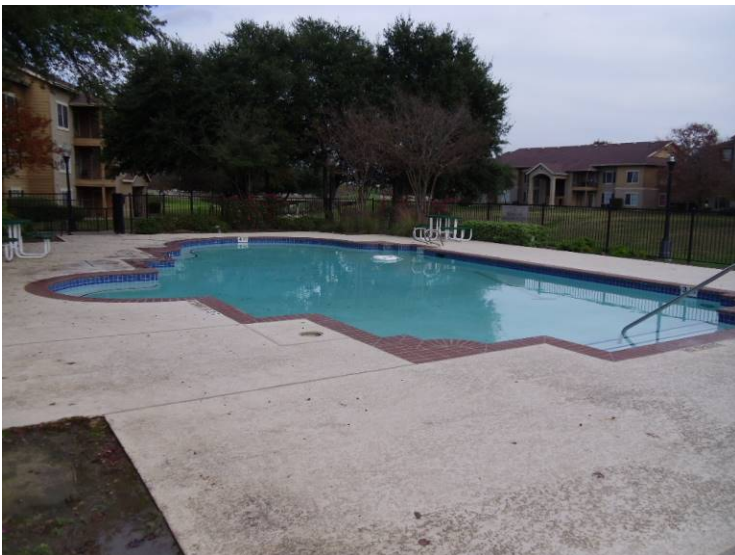
A swimming pool is provided behind the leasing office building. The pool's gross dimensions are 30'x50', and it varies from three (3) to five (5) feet deep. The pool has a plaster (Marsite) liner, pre-cast brick coping, and decorative tiles at the water line. The pool is in average to good condition, and no immediate repairs appeared necessary at the time of the site visit.

It is our understanding the swimming pool liner was last resurfaced about four (4) years ago. The typical useful life for the pool's plaster liners is about 10 years, so liner resurfacing and other repairs will be necessary during the loan term. The estimated cost for the work is provided below and included in the Repair and Replacement of Capital Items table in Appendix 3 of this Report.

- 33. A swimming pool is provided behind the leasing office building.

- **Reserve R&R – Pool liner repairs/resurfacing** **\$8,200**

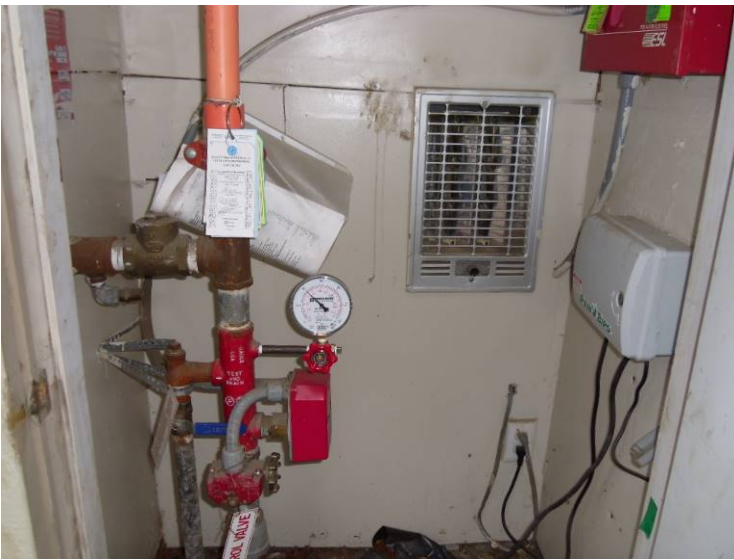
35. This is a view of a typical fire riser closet in buildings 2, 3, 5, 11, and 13. All code required components are present.

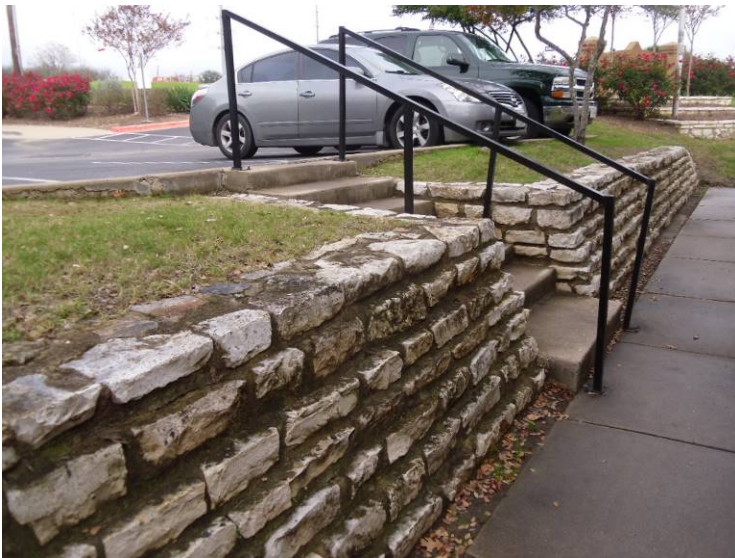
Mortared stone retaining walls have been installed at various locations to control grade differences between the buildings and the adjacent sidewalks and parking areas, and along the west perimeter of property between the Project Site and the adjacent properties. The retaining walls are in average to very good condition, and the remaining useful life should exceed the loan term with minimal maintenance.

38. Mortared stone retaining walls on the site are in average to good condition.

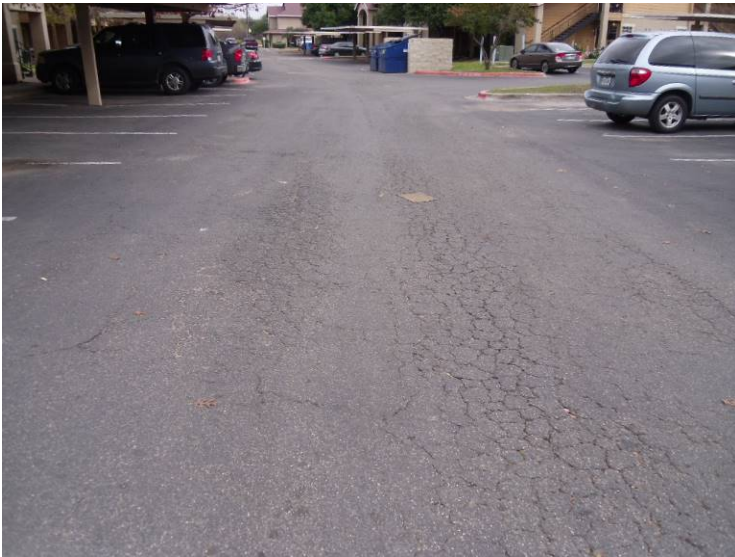
The driveways and parking lots are paved with 2” to 4” of asphalt over at least eight-inches of stabilized soil. The pavement was recently repaired and seal coated, small potholes and crack blocking (alligating) of the asphalt was observed at various locations. The repair of the potholes and areas of crack blocking is necessary where required. The estimated cost for the repairs is shown below and provided in the Immediate Repairs and Replacement table in Appendix 3 of this report.

- 43. Some of the asphalt pavement is showing evidence of stress and deterioration. Note the crack blocking asphalt pavement in this photo.

- **Immediate R&R – Asphalt pavement repairs** **\$1,500**

Asphalt pavement repairs will be necessary during the loan term. It is our opinion that about 1,200 square feet of pavement will need to be replaced during the 12-year loan evaluation period. The estimated costs for the repairs is provided below and included in the Repair and Replacement of Capital Items table in Appendix 3 of this Report.

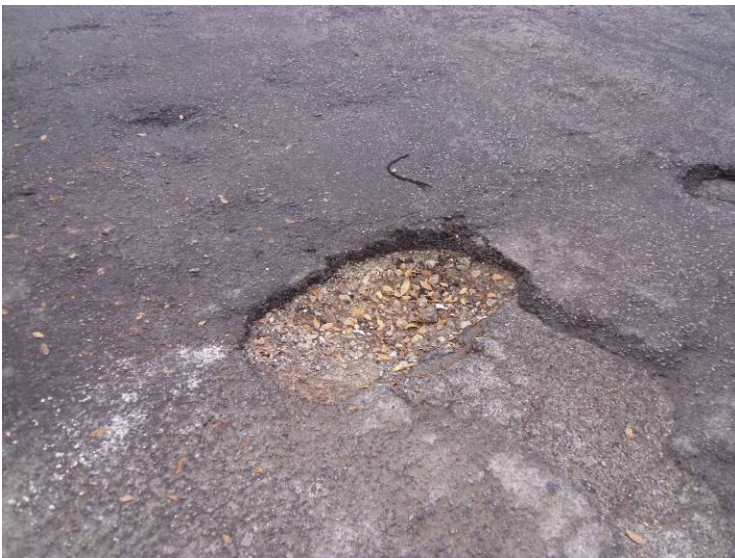
- 44. A few potholes were observed on the site that need immediate repair.

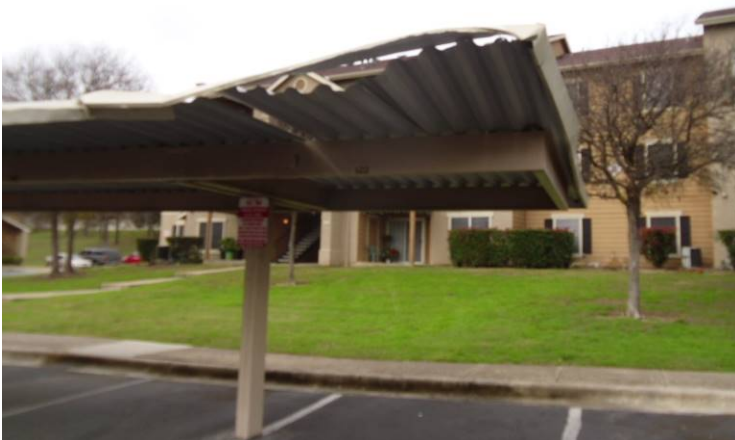
Thirty-eight (38) carports at the Project Site provide covered parking for 200 vehicles. The carports has metal frames, corrugated metal roofs, and sheet metal fascia. The metal support posts are set in concrete footings. Caged fluorescent light fixtures mounted to the metal frames provide illumination during nighttime hours. The carports are in generally good condition, but the corrugated roofs and metal fascia on several have been damaged by vehicles. Carport repairs are necessary at spaces 167, 170, 182/183, 210, 247, and 254. The estimated cost for the repairs is given below and included in the Immediate Repair and Replacement Cost Estimates table in Appendix 3 of this

- 45. Vehicular damage was observed on at least six carports that need immediate repair.

- **Immediate R&R – Carport roof repairs** **\$800**

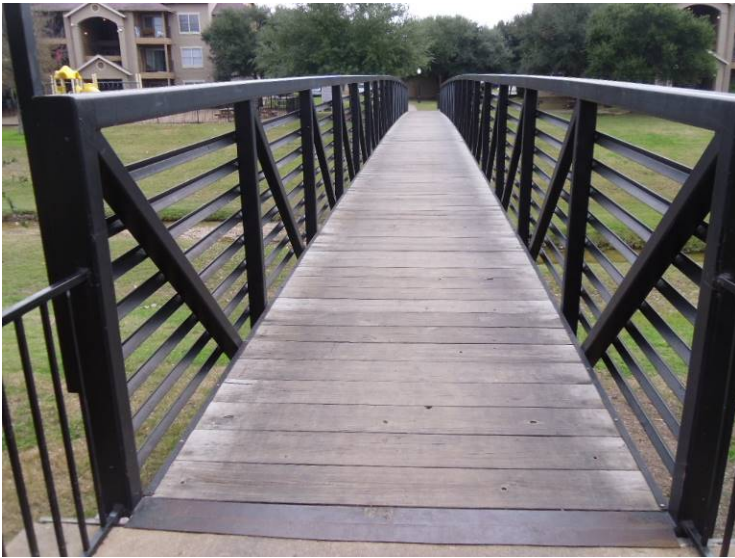
47. The footbridge is in very good condition and well maintained.

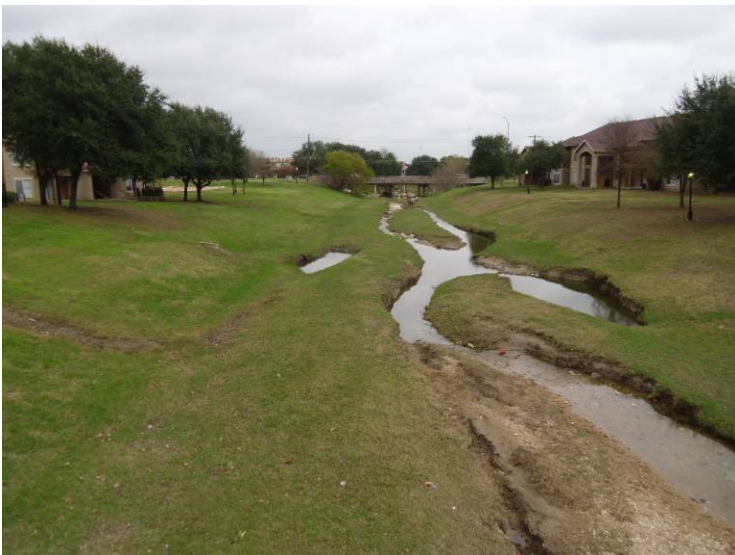
Community map No. 484530605H, dated 09/26/2008, indicates the areas of the Project Site that contain the office and residential buildings is located in Flood Zone X. FEMA defines flood zone X as "areas outside the 100 and 500-year floodplains". However, areas within the flood plain for the creek are in located in Flood Zones X (shaded) and AE. Flood zone X (shaded) includes "areas of 0.2% annual chance flood", and Zone AE is defined as "where base flood elevations [have been] determined". No visual evidence of prior flooding was observed. A copy of the FEMA flood zone map is included in Appendix 5.

48. The creek flood plain is located in flood zone AE, but all buildings are located in flood zone X.

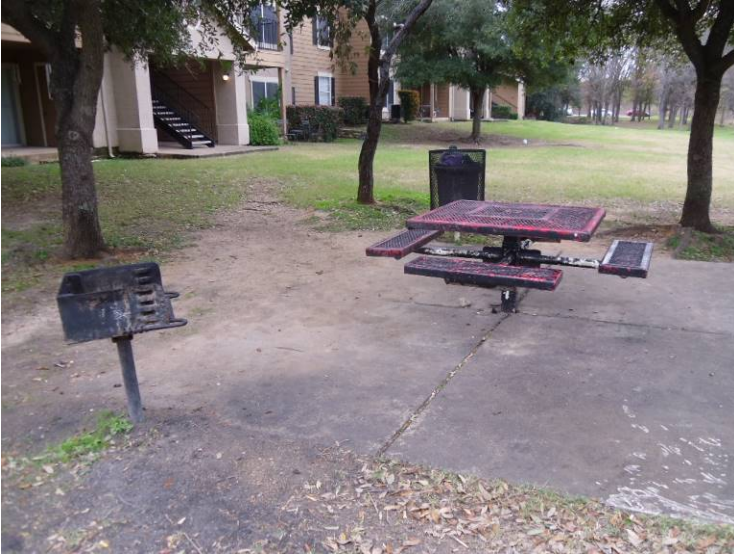
Picnic tables and charcoal fired BBQ grills are provided at several locations on the site. The metal picnic tables have metal mesh table tops and are configured with four metal benches that are welded to a steel support post that is set in concrete footings. Standard steel post mounted BBQ grills are located near the picnic tables. The tables are in average condition but are in need of painting. The grills are in fair to average condition. Grill and table repairs are completed when necessary by the site staff or contract vendors using the routine maintenance budget.

- 49. Picnic areas are provided at several locations on the site. Minor repairs and painting are necessary, but the work can be completed by the site staff.
